SI-220513
Service-Information Turbocharger

Turbocharger with different position sensors leads to malfunctions if interchanged

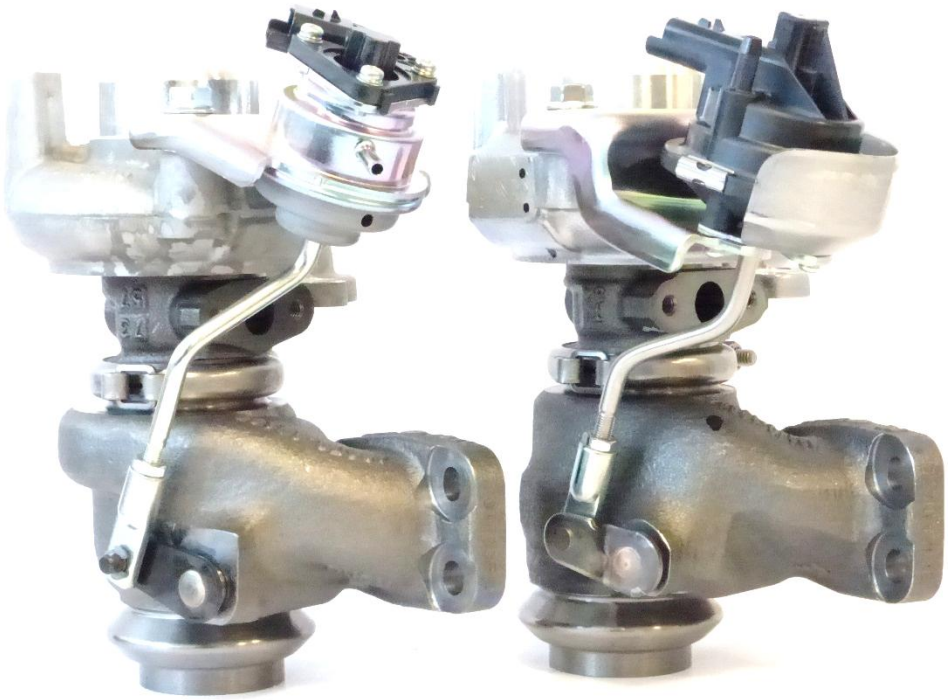
T915913 (49373-02013) T981435 | T918323 (49172-03000) T981653

Note:
These turbochargers cannot be replaced, even if the connector on the vehicle side can be plugged in. The turbochargers differ in the signal voltage values of the position sensor. Incorrect application results in fault memory entries and emergency running function.

The distinguishing feature is the vacuum actuator with position sensor.

Instructions:
Before starting the assembly work, the turbocharger supplied has to be compared with the old part.
The check has to be carried out before filling the turbocharger with the initial filling additive.
